Manhole Inspection Summary

Manhole # S45W__008MH

Location Address: **1307 towson**

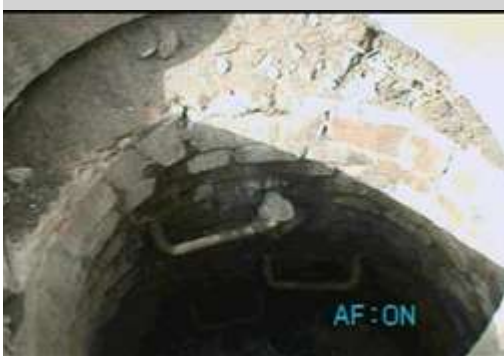
Defect 2

Steps Count: **3** Missing: **0** ☒ **Corroded**

steps

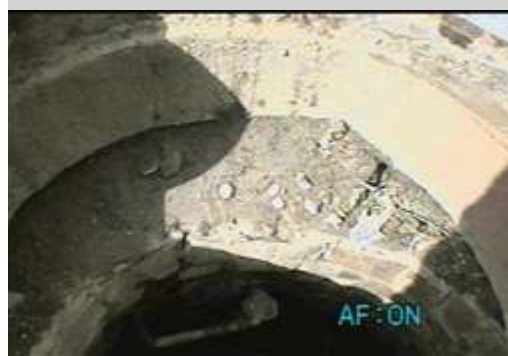
Defect 1

Frame Offset: **6** (in.) Condition: ☒ Sound ☐ Cracked ☐ Leaks

offset

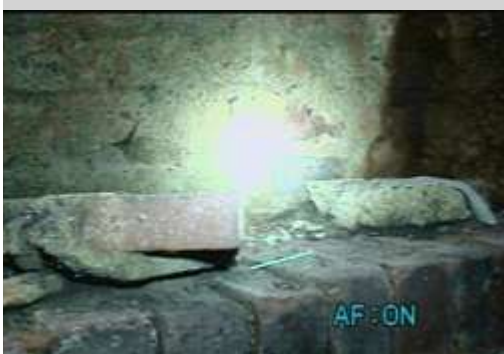
Defect 3

debris

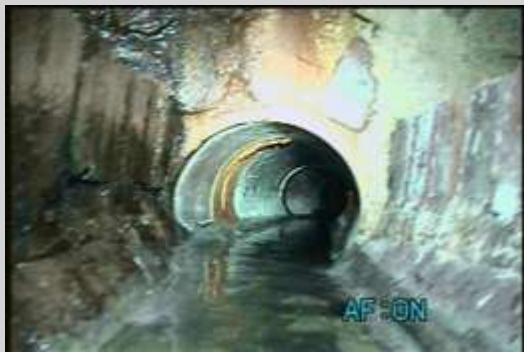
12 O'Clock Outflow

8 in. Circular Gravity Sewer
Pipe Out @ 12 O'Clock

Pipe Material: **Clay** ☐ Pipe Lined

Invert Depth: **8.30** (ft.) Flow Characteristics: **Slow**

Deposits: ☒ None ☐ Mud ☐ Sludge ☐ Debris ☐ Grease

Infiltration: **None** Pipe Seal Cond: **Unknown**

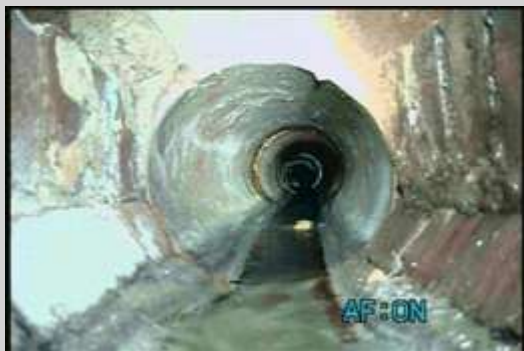
6 O'Clock Inflow

8 in. Circular Gravity Sewer
Pipe In @ 6 O'Clock

Pipe Material: **Clay** ☐ Pipe Lined

Invert Depth: **8.20** (ft.) Flow Characteristics: **Slow**

Deposits: ☒ None ☐ Mud ☐ Sludge ☐ Debris ☐ Grease

Infiltration: **None** Pipe Seal Cond: **Unknown**
